FORM B – BUILDING

AVO.25

Address: 271 East High Street

Historic Name: Old Colony Railroad -- Avon Station

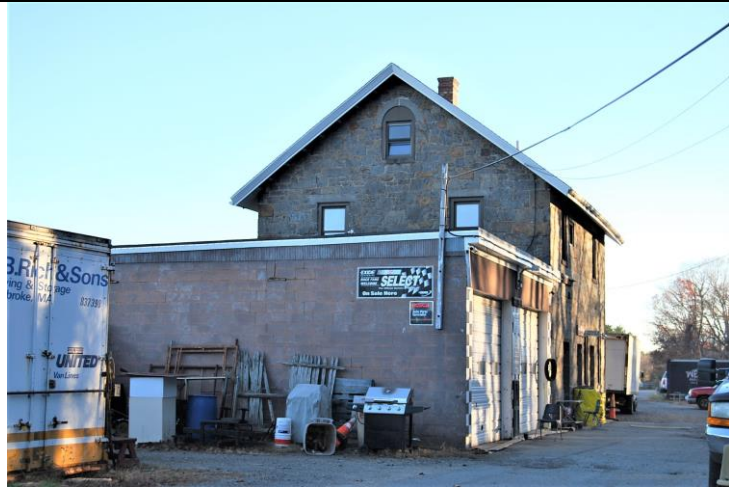
View looking south.

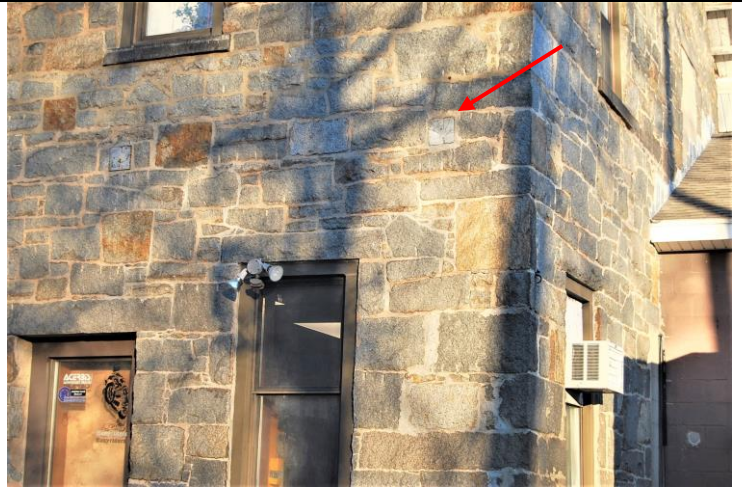
Detail. Stonework and wood nailers where shelter was attached.

Major Alterations (with dates): Trackage shelter removed (before 1954); North ell added (between 1954 and 1958); South ell added (after 1958); Replacement metal sash windows (late 20th C or early 21st C)

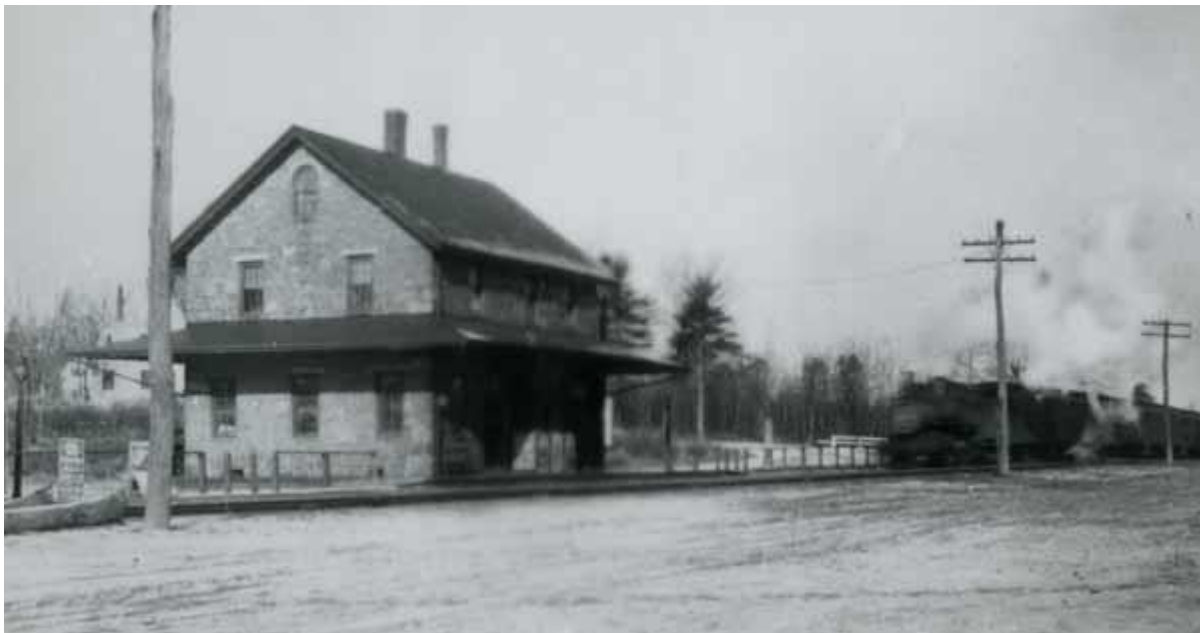
Ca. 1950-1954. Postcard view, looking northwest. Note the shelter that encircled the building.
<http://www.nashuacitystation.org/station/massachusetts/norfolk/holbrook/avon/>.
