# FORM B – BUILDING

**Address:** 37 West High Street

**Historic Name:** Clark Dairy Farm Barn

# INVENTORY FORM B CONTINUATION SHEET

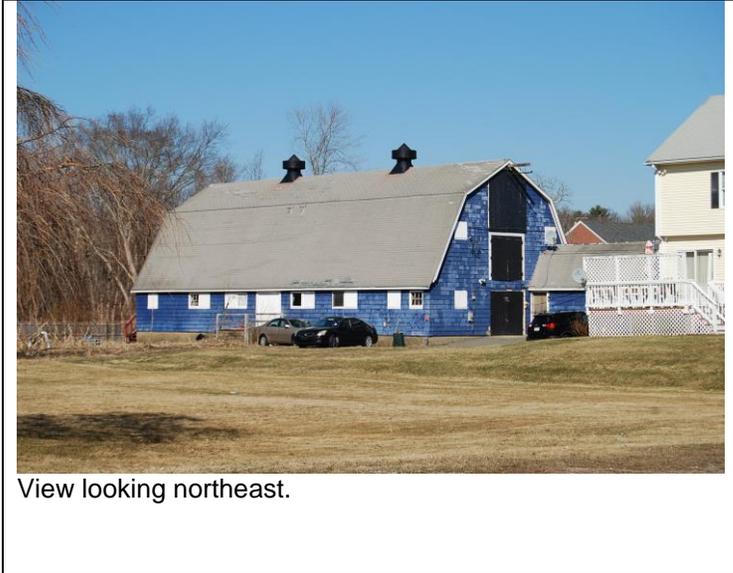
## Photograph

**Condition:** Good

The ground-level stable barn rests on a poured concrete foundation and is capped with a gambrel roof with overhanging eaves. Two metal ventilators are located on the roof ridge. The south (streetside) elevation contains three levels of centered vertical board-and-batten, side-hung, double-leaf doors. A metal track extends from the gable peak, above the hayloft door. The side (east and west) elevations are seven bays deep. The east elevation contains seven pairs of small 6-light, wood-sash windows. The west elevation contains six pairs of small, 6-light wood sash windows and a wide vertical-board wood door at center. (Some of the windows have been replaced with fixed glass or plastic panes.) A 1-story, gambrel-roof milk house is attached to the east end of the south elevation. A pedestrian door is located in the north end of the west elevation. The south elevation contains two small rectangular window openings and a 6-light window in the gambrel peak. A single small window is located in the east elevation of the milk house.

The building is a good example of a ground-level stable barn, a form that became popular in the 1920s. The building's poured concrete floor, deep gambrel roof, metal roof ventilators, and milk shed are all character-defining features. The building retains a high level of integrity.

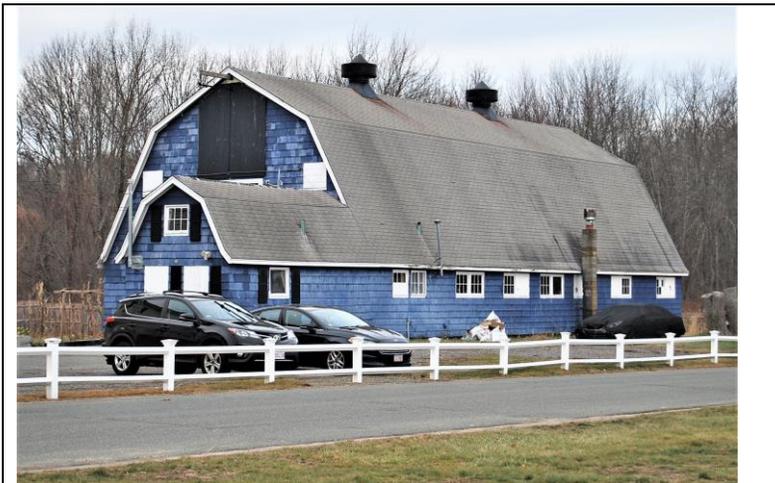
View looking northwest.
