FORM B – BUILDING

Town/City: Avon

Address: 70 Gill Street

Historic Name: Robert and Susan Wilson House

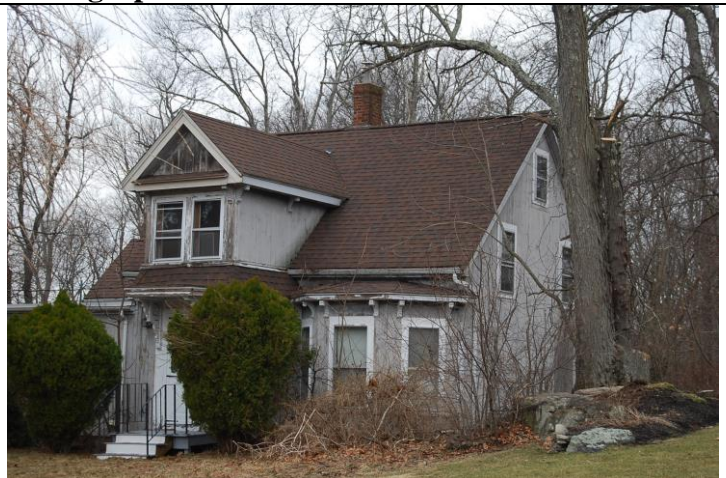
View looking northwest.

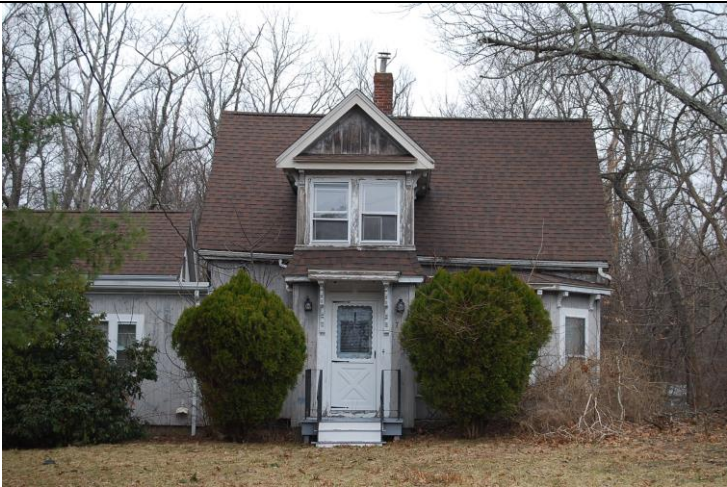
The 1½-story main block has a side-gabled roof with overhanging eaves. A slender brick interior chimney rises from the north (rear) roof slope. The façade features an off-center entrance containing a paneled wood door with a single light filling the top half. Large jigsawed wood brackets support a shallow roof above the entrance. The entrance is contained within a projecting bay that connects to a gable dormer above via a flared roof. The pedimented dormer contains a pair of windows with decorative wood brackets under the overhanging eaves. A wide bay window with a hipped roof and bracketed eaves fills the east end of the façade. The side (east) elevation is two bays deep with a single window centered in the gable peak. The rear block, located near the northeast corner of the main block is one bay deep and capped with a side-gabled roof with overhanging eaves. A shed-roofed projection is attached to its rear (north) elevation. Windows throughout the main block and rear block are 1/1 wood sash with exterior, metal-frame storm windows. Window surrounds are constructed of wide, flat wood trim.

Façade. View looking north-northwest.

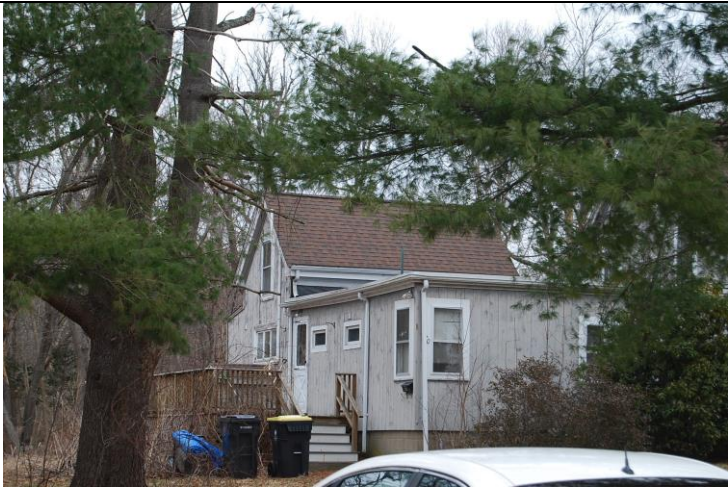
View looking north toward ell.

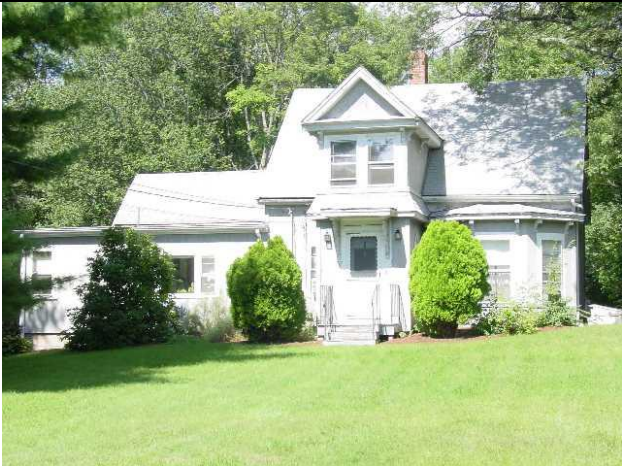
The one-story connector forms the southwest corner of the house and is attached to the west elevation of the main block and the south elevation of the rear block. This connector rests on a concrete block foundation. The south elevation contains a trio of sash windows and a single sash window. The west elevation contains a single sash window, two hopper windows, and an entrance with a Colonial Revival-style metal storm door. A wood deck constructed of pressure-treated dimensional lumber is attached to the west elevation.

Assessor's photograph showing clearer view of connector.
