Re: Antone Road, Avon  
ANRAD Filing; DEP #099-0178

The purpose of this report is to show that the connections made during the June 11, 2020 peer review, which connected the isolated wetland to the on-site Bordering Vegetated Wetland was not supported with 50% or more wetland vegetation in several areas.

**PLAN TO ACCOMPANY ANRAD FILING FOR ANTONE ROAD IN AVON MASSACHUSETTS**

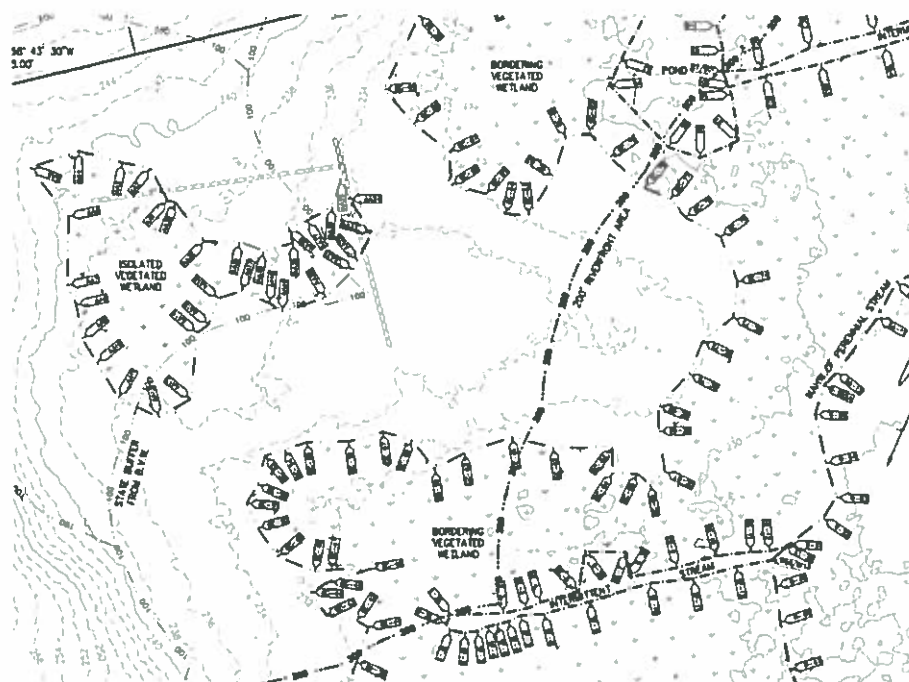
Figure 1. Original wetland delineation showing isolated wetland.

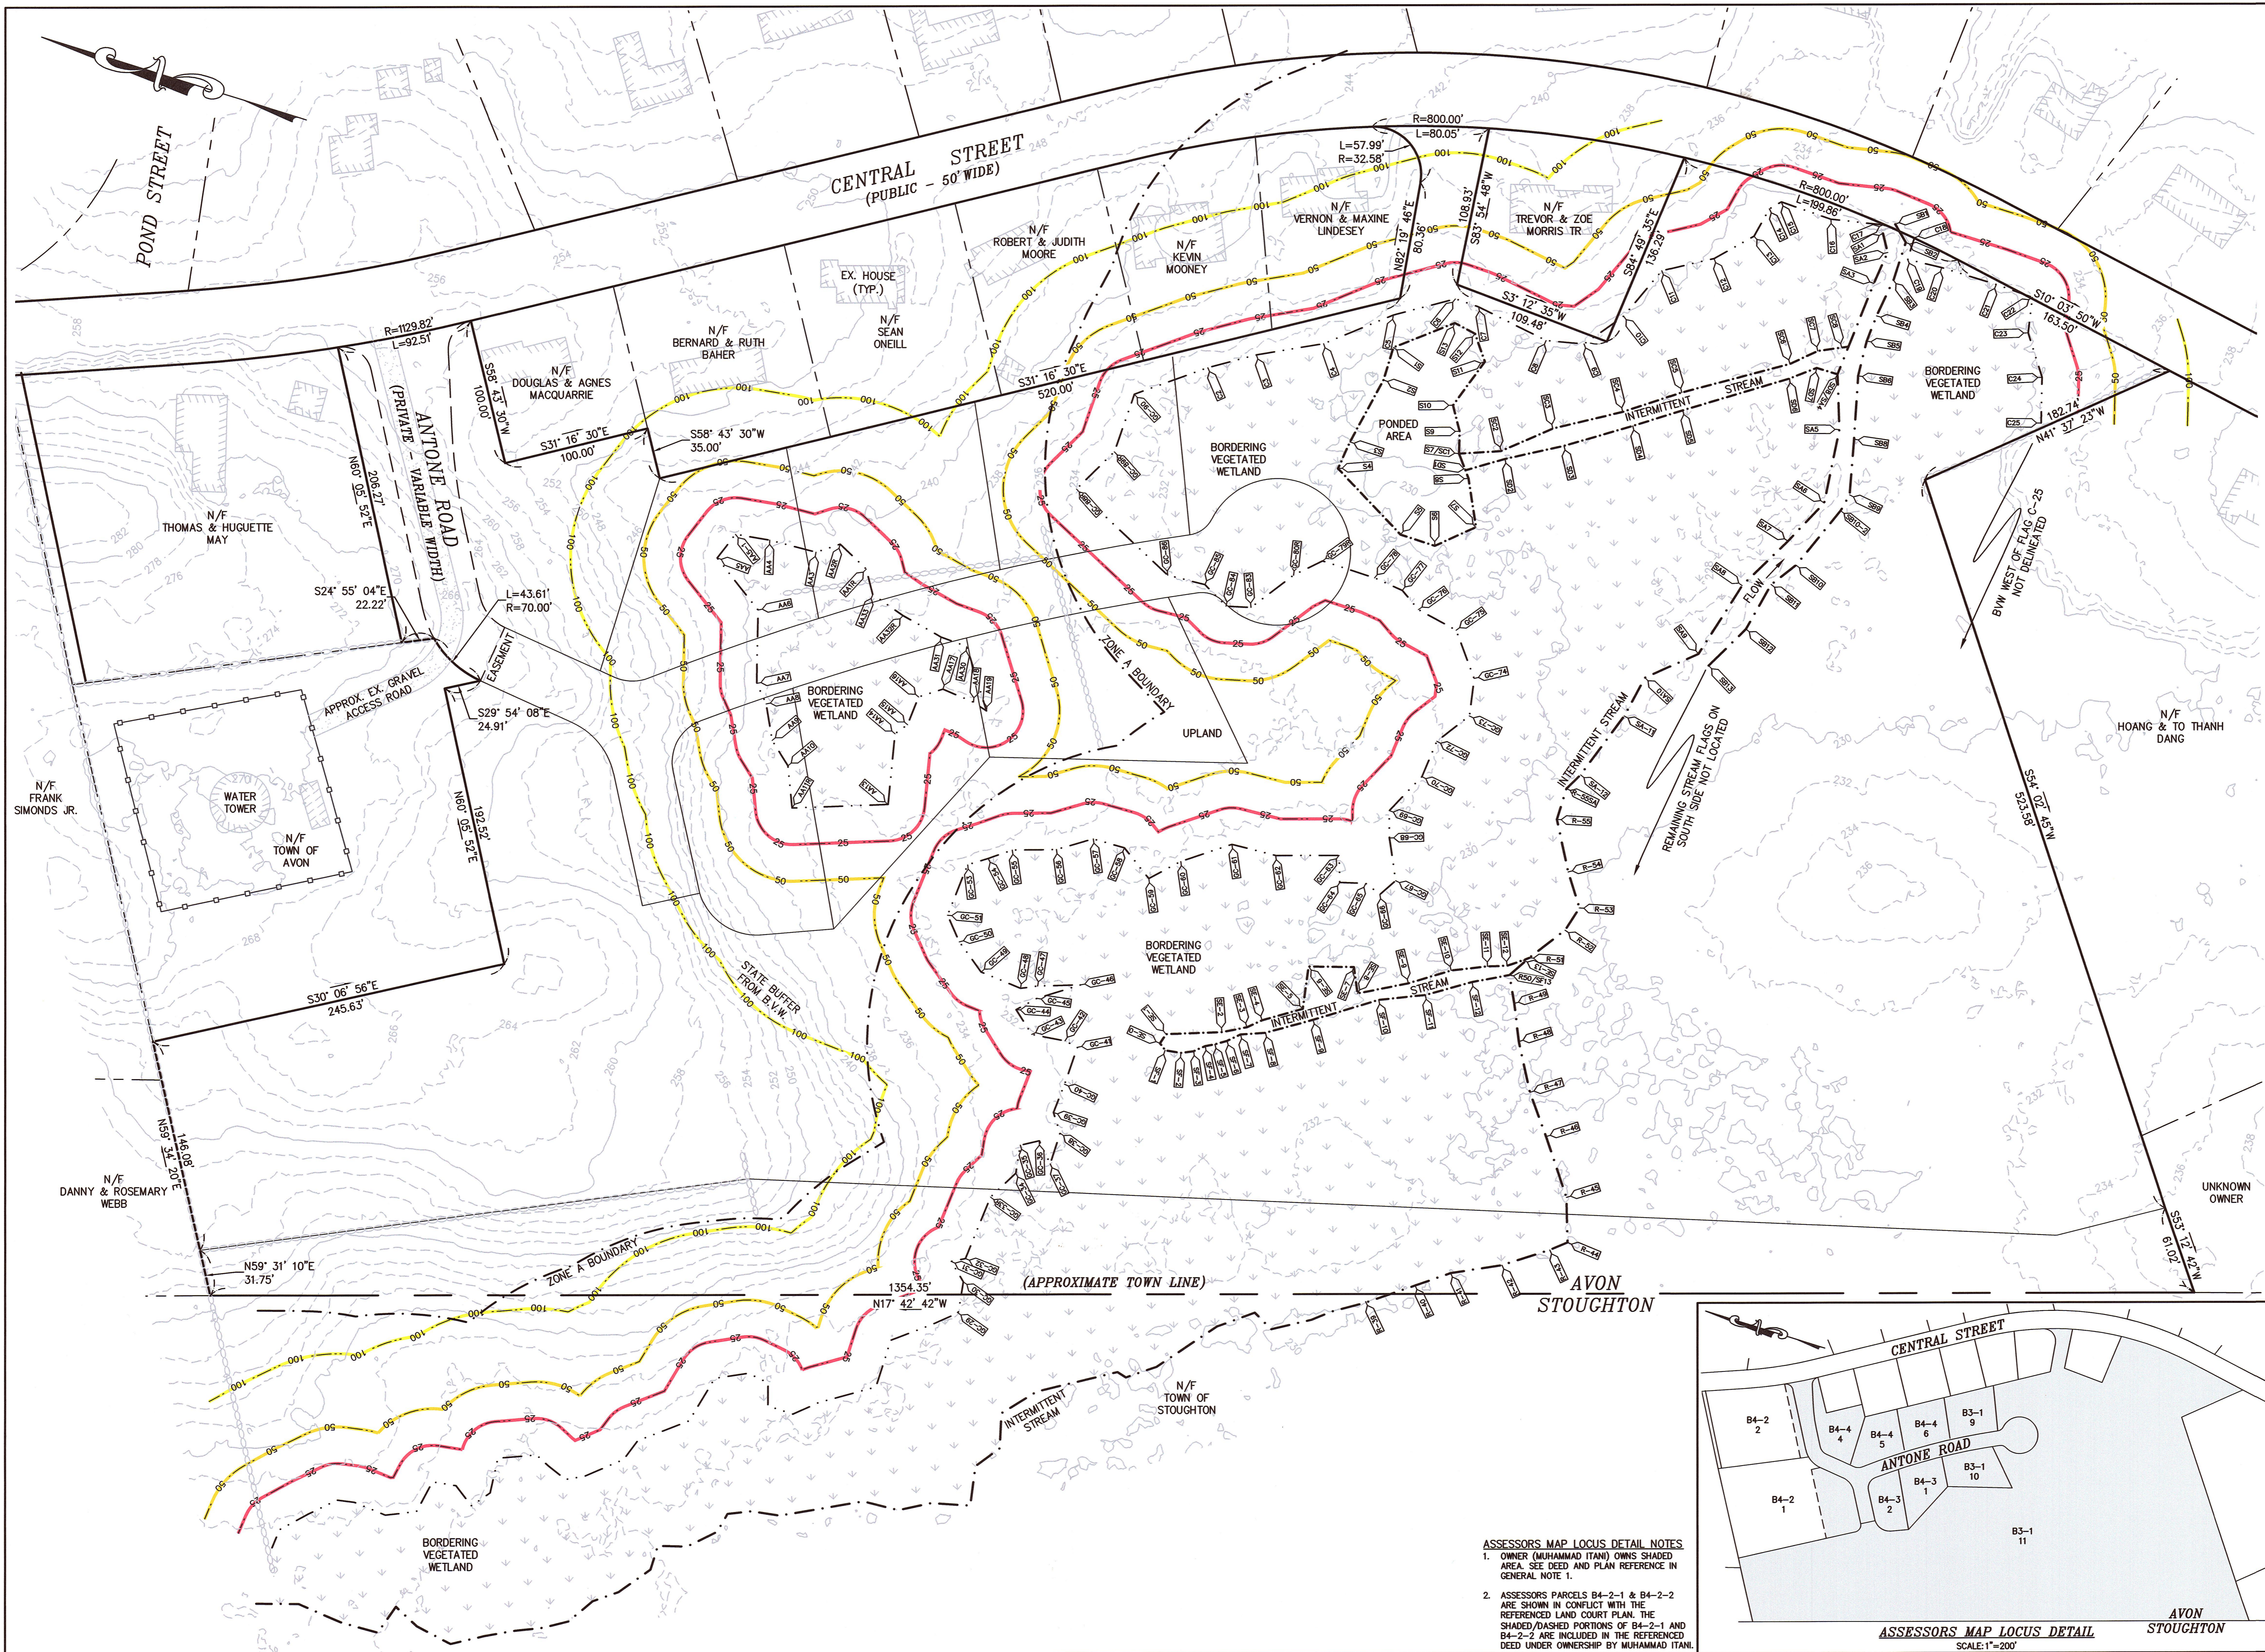
2. THE SITE FALLS WITHIN ZONE X, AREA OF MINIMAL FLOOD HAZARD, AND ZONE X, AREA WITH A 0.2% ANNUAL CHANCE FLOOD HAZARD OR 1% ANNUAL CHANCE FLOOD WITH AVERAGE DEPTH OF LESS THAN ONE FOOT OR WITH DRAINAGE AREA OF LESS THAN ONE SQUARE MILE. FLOOD INSURANCE RATE MAP NUMBER: 250210381E, EFFECTIVE DATE: 7-17-12.
