FORM B – BUILDING

Town/City: Avon

Address: 82 West High Street

Historic Name: Dennis and Mary Shean House

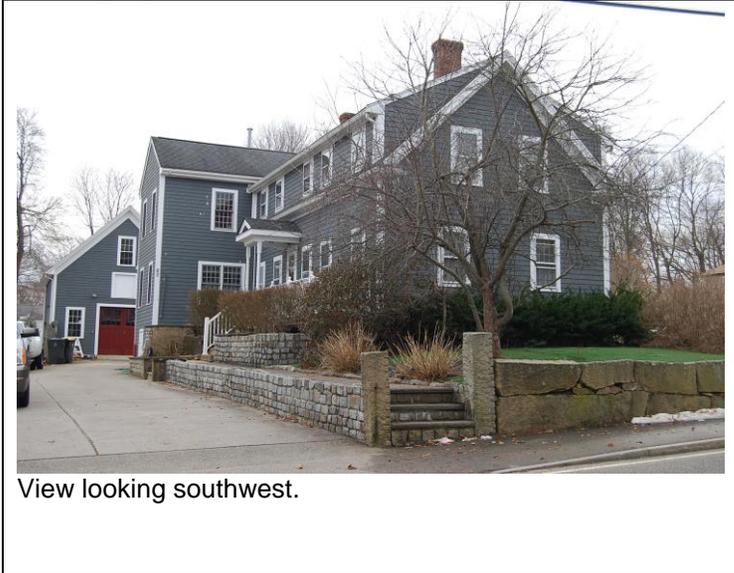
Photograph

The house consists of a 1½-story main block and a perpendicular 2-story ell, both of which rest on a cut stone foundation. The main block is capped with a gabled roof with overhanging eaves and gable-end cornice returns. Two brick chimneys with corbeled caps are located at the roof ridge. Shed dormers extend the length of the east and west elevations. The house is two bays wide at the north gable end and six bays wide along the east elevation. The façade contains an off-center entrance sheltered by a small, pedimented porch supported by turned wood posts (late 20th or early 21st C). Windows in the north and east elevations are 12/12 wood sash with exterior metal-frame storm windows and wide, flat surrounds. Two bays of large casement windows are located on the west elevation. Windows in the shed dormers are 6/6 wood sash.

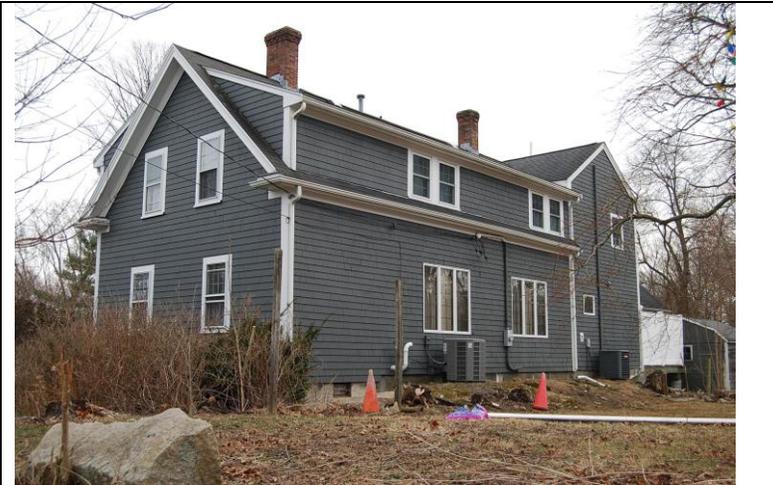
View looking southeast toward north and west elevations.
